SUCKER BROOK DAM AND RESERVOIR

DESIGN MEMORANDUM NO.9

HIGHLAND LAKE DAM MODIFICATIONS

JANUARY 1966

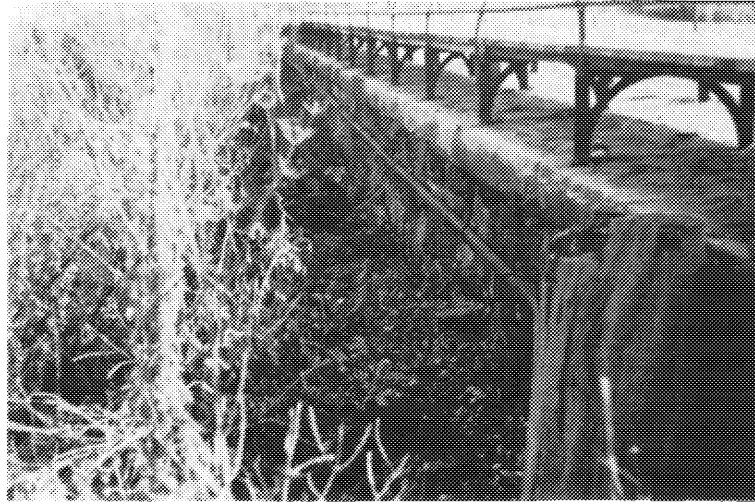
Downstream Face Of West Spillway. Note Vegetation And Absence Of Rock Splash Apron. 11/3/65

- b. Overflow Section - Heavy cover stone will be placed at the downstream face of the dam to absorb the impact forces of the discharge from the overflow sections. This cover stone will be 2000 lb. stone or larger placed for a distance of 24 feet downstream of the face of the dam. It will consist of a three-foot layer on a two-foot filter bed of quarry run stone. Along the upstream face, additional dumped rock will be placed on the westerly two-thirds of the dam to protect against erosive forces.

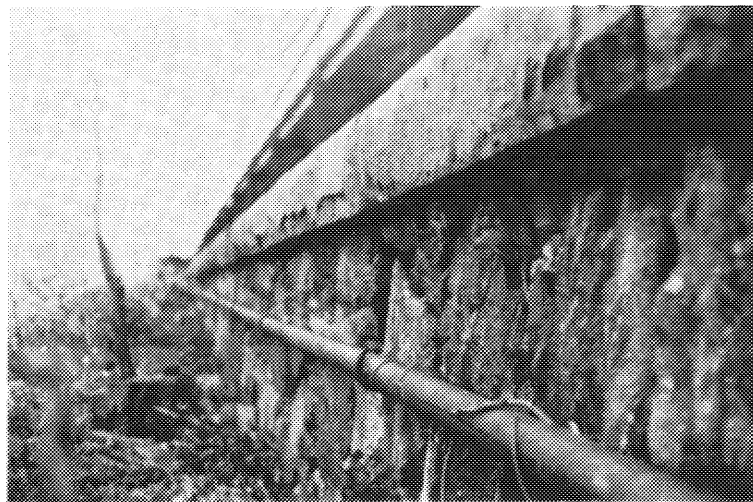
Downstream Face Of West Spillway Showing Condition Of Wall And Overhang Of Capstones. 11/3/65

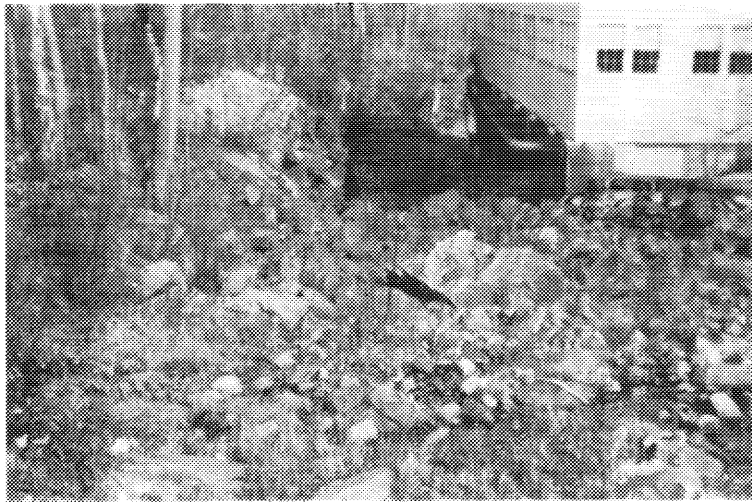
Looking Downstream Along East Spillway's Exit Channel Adjacent To Union Pin Company Building At Intersection Of Both Spillway Exit Channels. Note Size And Extent Of Rock. 11/3/65

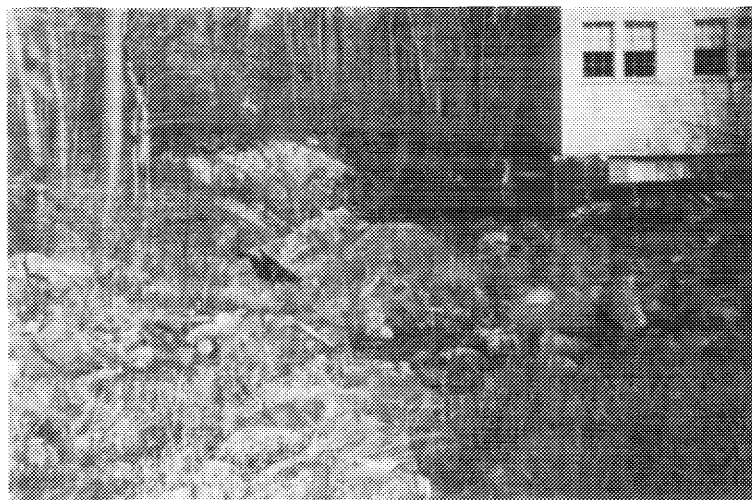
Looking Downstream Along East Spillway's Exit Channel Adjacent To Union Pin Company Building At Intersection Of Both Spillway Exit Channels. Note Size And Extent Of Rock. 11/3/65

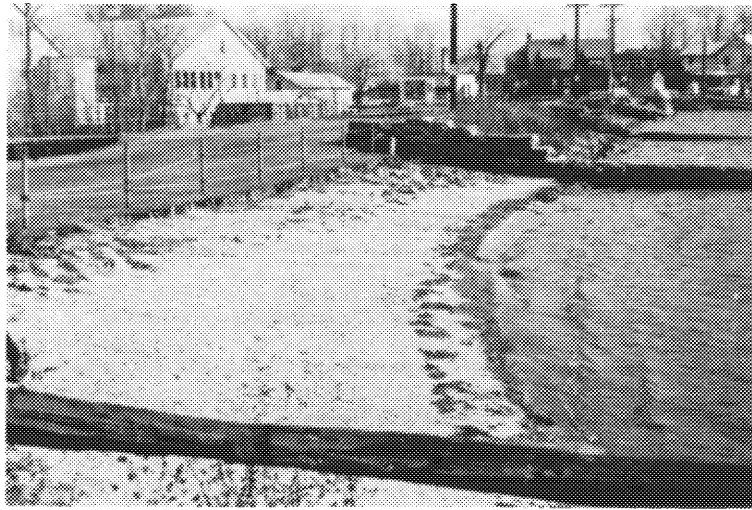
Upstream Face Of Highland Lake Dam - West Spillway In Fore-ground - Union Pin Company At Upper Left. 11/3/65

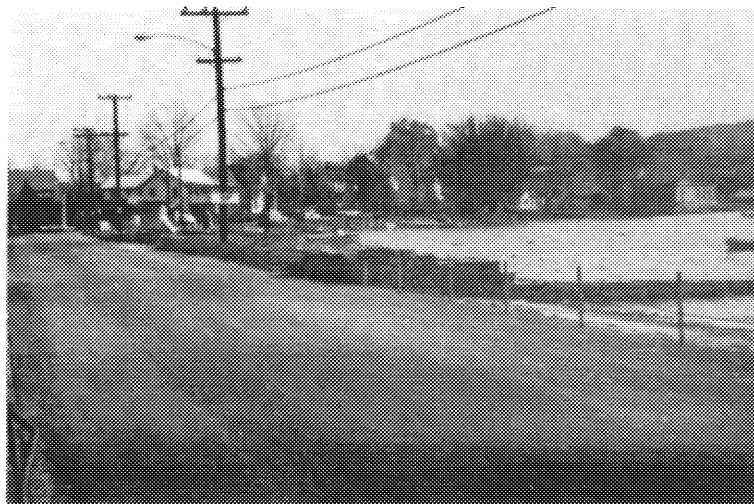
Looking Easterly From Centerline Of West Spillway Along Upstream Face Of Highland Lake Dam - East Lake Street Property In Background. 11/3/65

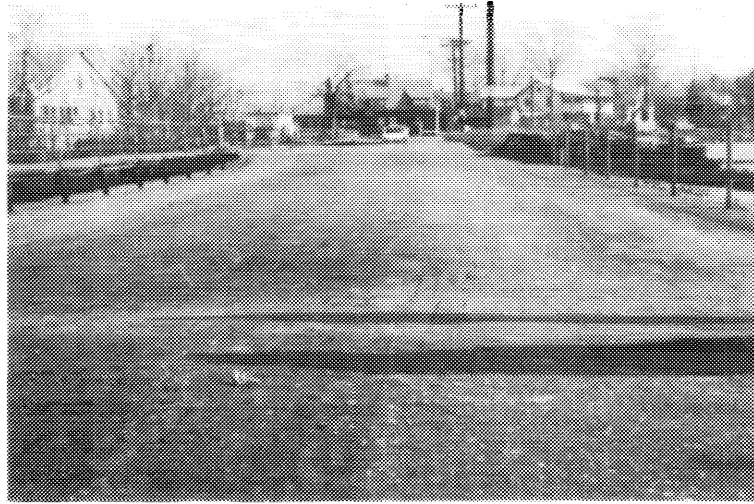
Looking Easterly Along Centerline Of Dam - Note Two Depressed Sections Of Roadway Serving As Overflow Spillways - Union Pin Building At Left Edge Of Photograph. 11/3/65

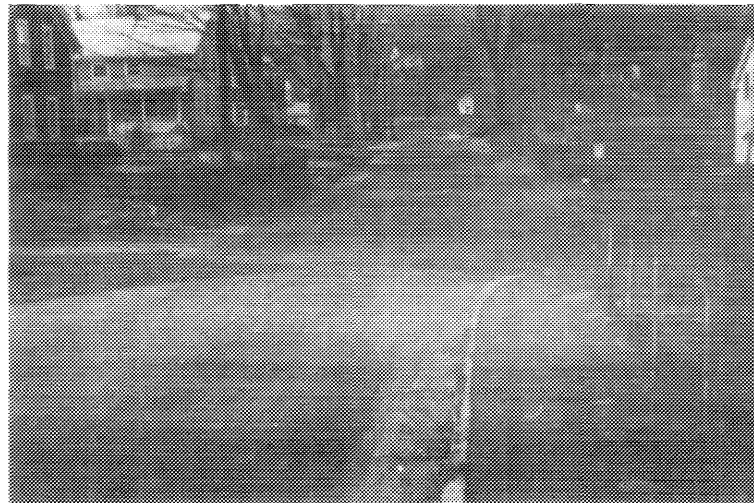
Intersection Of West Lake Street And Woodland Avenue - Looking West From Edge Of West Spillway At Low Elevation Of The Roadway Intersection. 11/3/65

- a. Westerly Abutment - Approximately 300 feet of low dike will be constructed from high ground northerly of West Lake Street extending to the knoll east of the Laurel Lodge Club. Approximately 260 feet of the dike will be constructed from the easterly side of the same knoll returning to West Lake Street at the westerly edge of the overflow sections. Top width will be six feet with side slopes of 2H:1V on the lake side and 3H:1V on the land sides. Dumped rock will be provided on the lake side face of the easterly dike for protection against erosive forces. Two sand bag closures will be provided at West Lake Street.

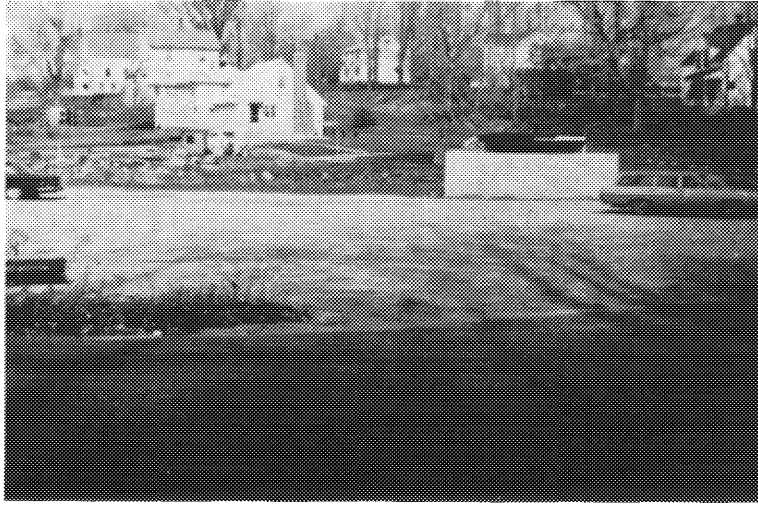
**Location Of Proposed Dike At East Lake And Hurlbut Streets
At Left Hand Edge Of Photograph. 11/3/65**

- d. Hurlbut and East Lake Streets - To preclude overflow through the low topographic saddle, 295 feet of low dike will be constructed in the beach area tying to high ground at each extremity. The dike will be of compacted fill with top soil and seed placed on top and side slopes. The cross section of the dike will consist of a 12-foot top width and side slopes of 4H:1V to facilitate continued use of this bathing area.

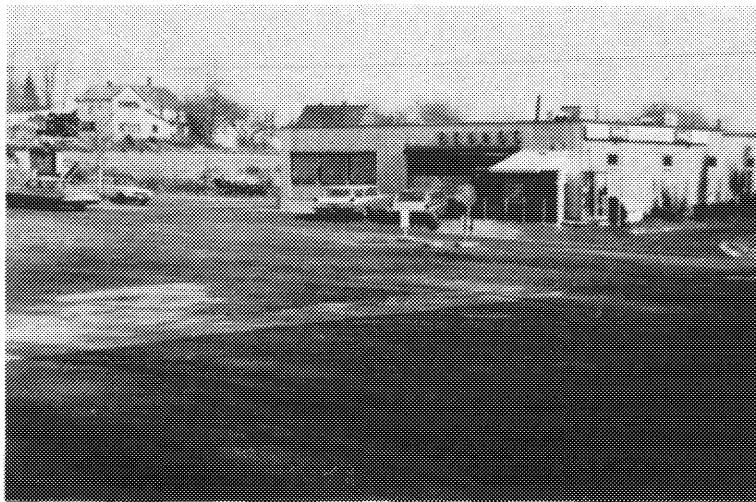
**Building Fronting On East Lake Street In Vicinity Of Proposed
Dike At Southeast Corner Of Highland Lake. 11/3/65**

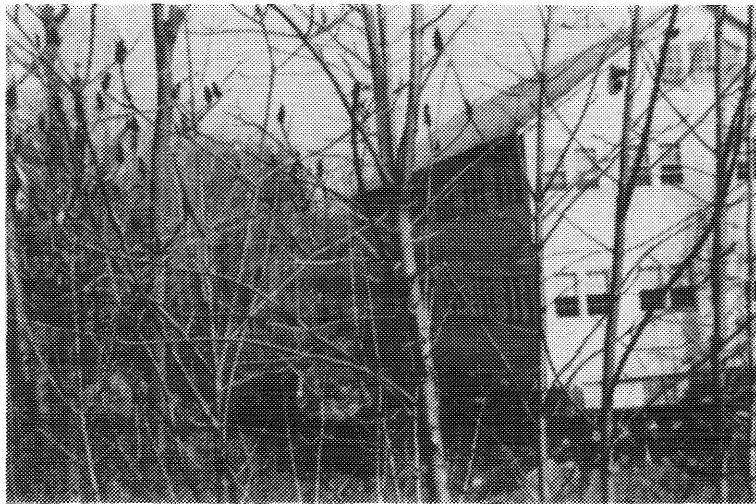
Looking Downstream At East Spillway Exit Channel Adjacent To Union Pin Company Building. 11/3/65

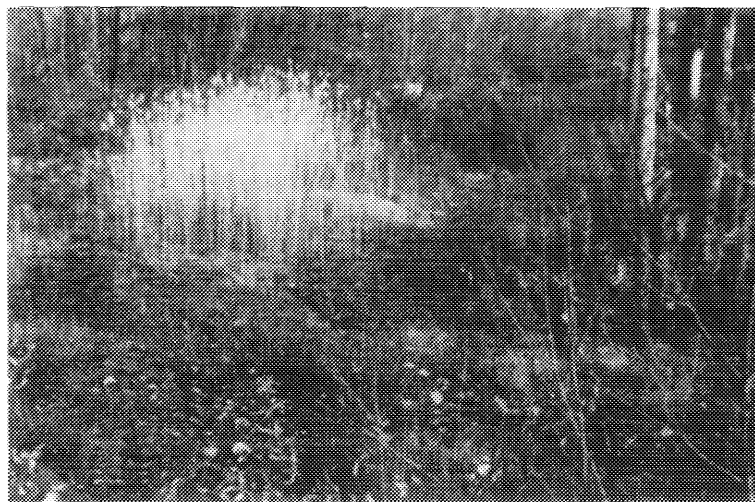
Looking Downstream At West Spillway Exit Channel. 11/3/65

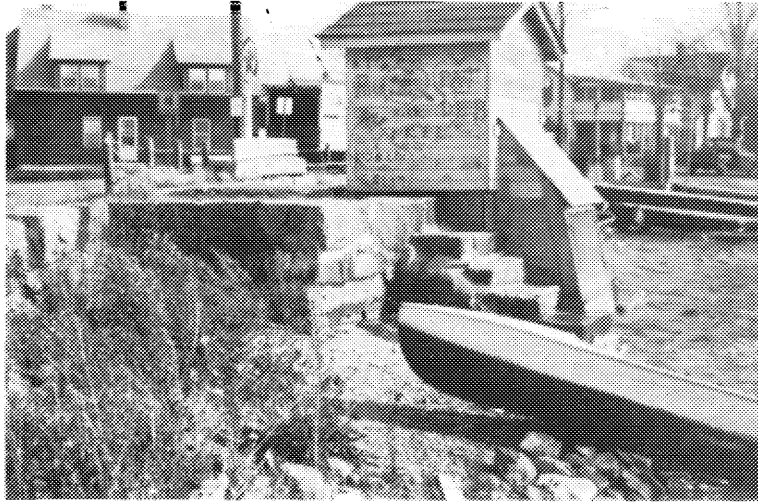
Gate House And Entrance Structure With Trash Racks. Boat Launching Ramp And Dock In Right Background. 11/3/65

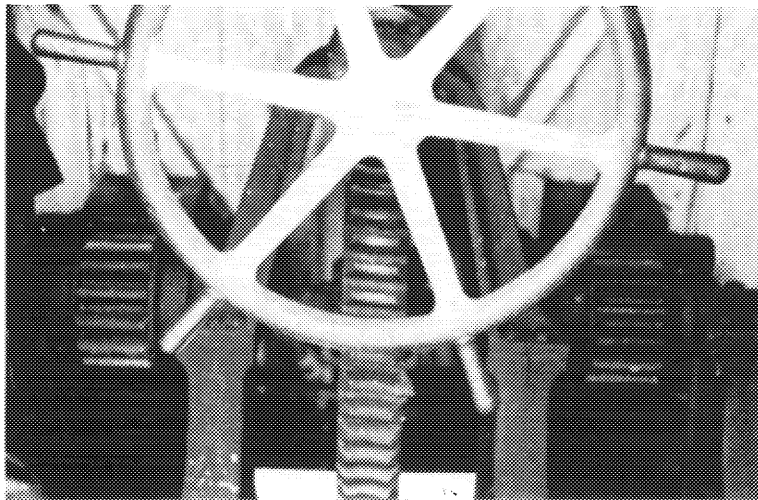
Inside Of Gate House. 11/3/65

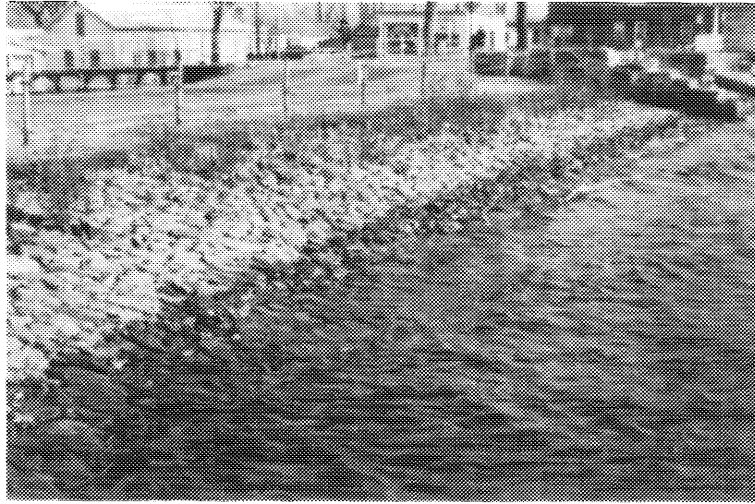
East Spillway's Upstream Face Showing Present Good Condition Of Stone Paving - Gate House For Union Pin Company Withdrawals In Upper Right Hand Corner Of Photograph. 11/3/65

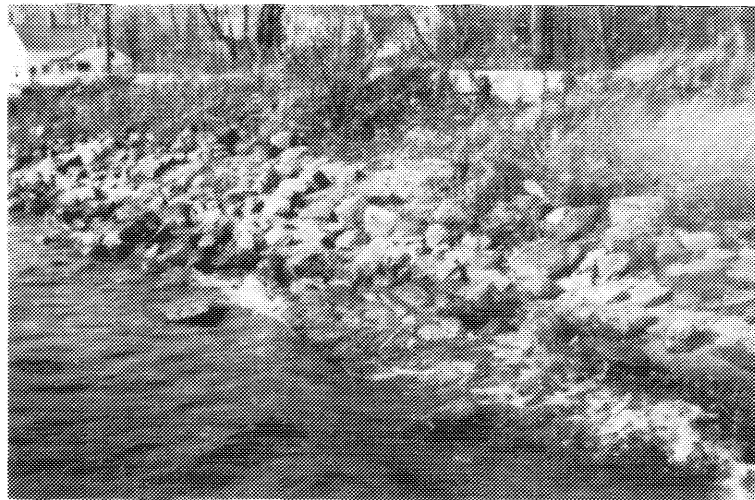
Upstream Face Of Highland Lake Dam Showing Condition Of Stone Facing Of The Center Section Of Dam Between The Two Spillways. 11/3/65

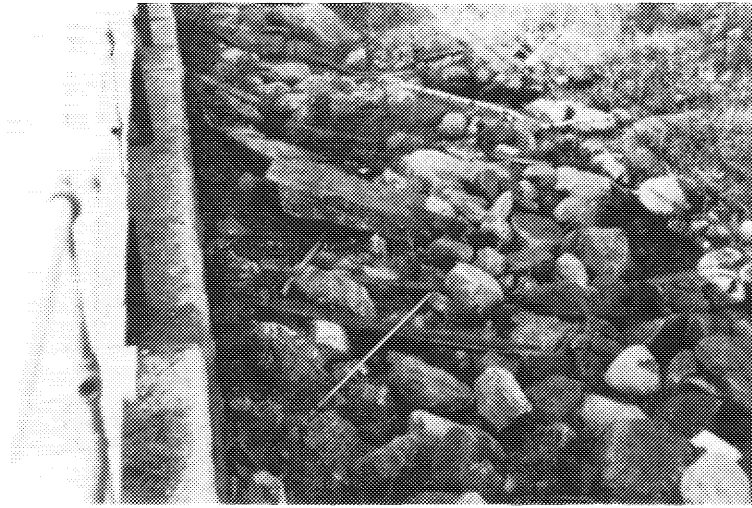
Downstream Toe Of East Spillway Showing Boardwalk, Granite Cap Of Stone Masonry Wall And The Present Splash Apron Of Miscellaneous Stone. 11/3/65

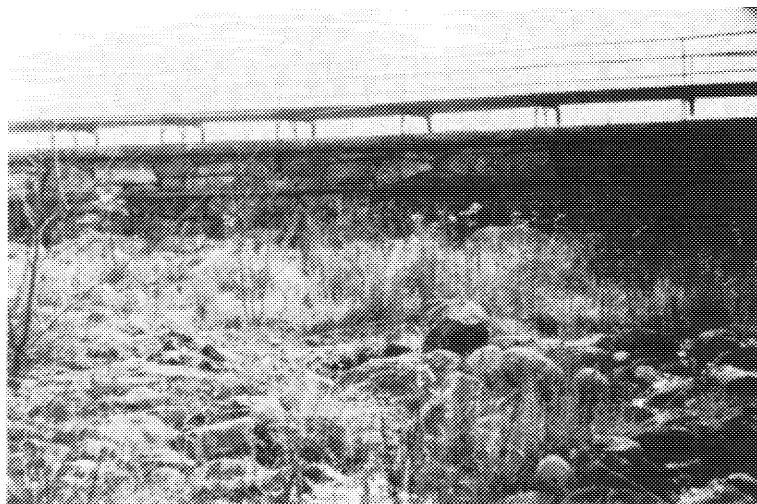
Looking Upstream At East Spillway's Stone Masonry Wall And Boardwalk. 11/3/65

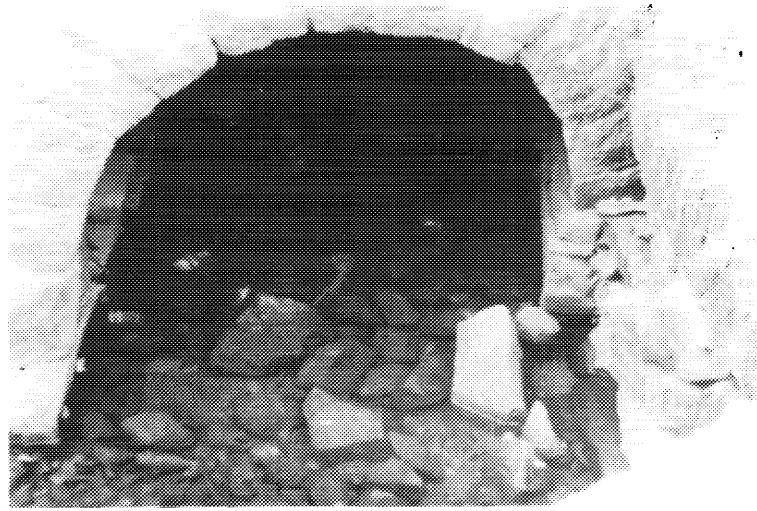
Outlet Of Conduit Through Highland Lake Dam At East Abutment Which Provides Water To Union Pin Company - Looking Upstream Control Gate Closed. 11/3/65

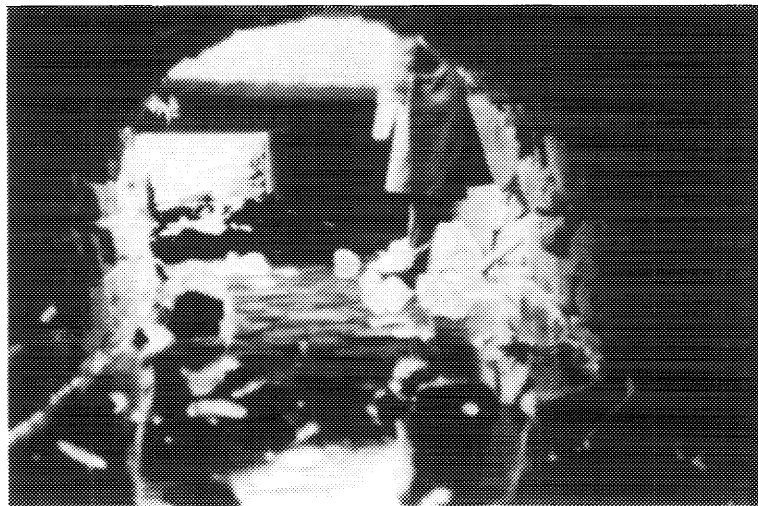
Looking Downstream From Inside Of Conduit Through Highland Lake Dam - Note Access Bridge To Union Pin Company. 11/3/65
